ERDC TR-01-17

## **Seismic Testing of a 1/20 Scale Model of Koyna Dam**

November 2001

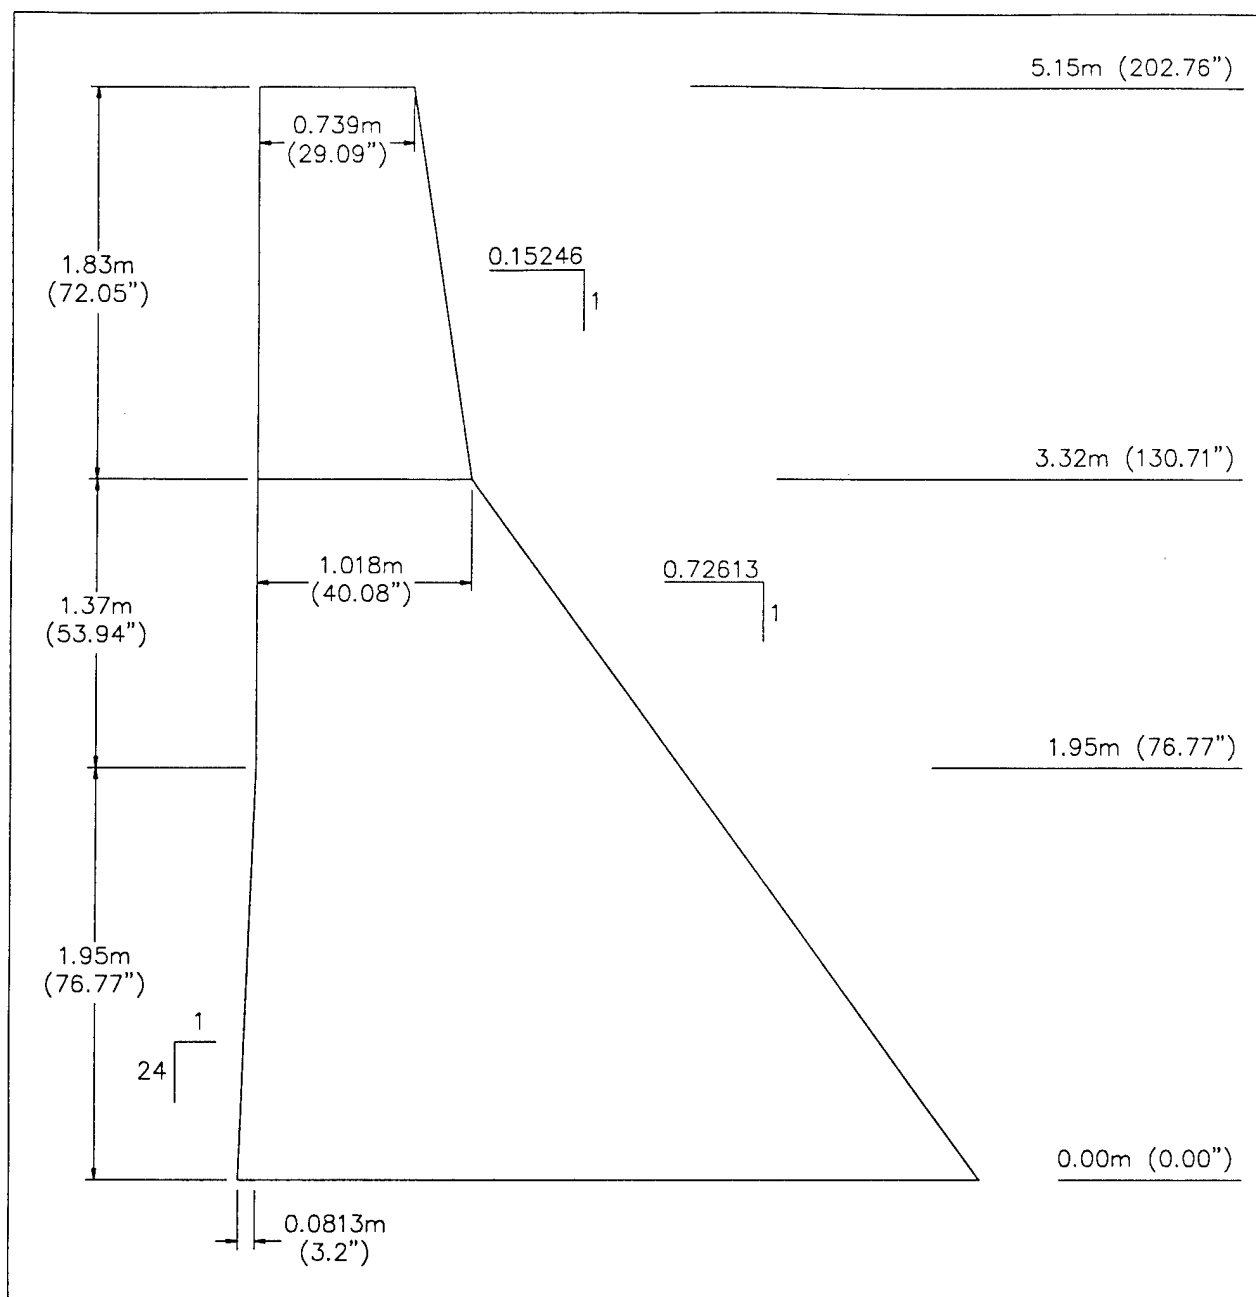
Figure 1. Design dimensions of the Koyna Dam model.

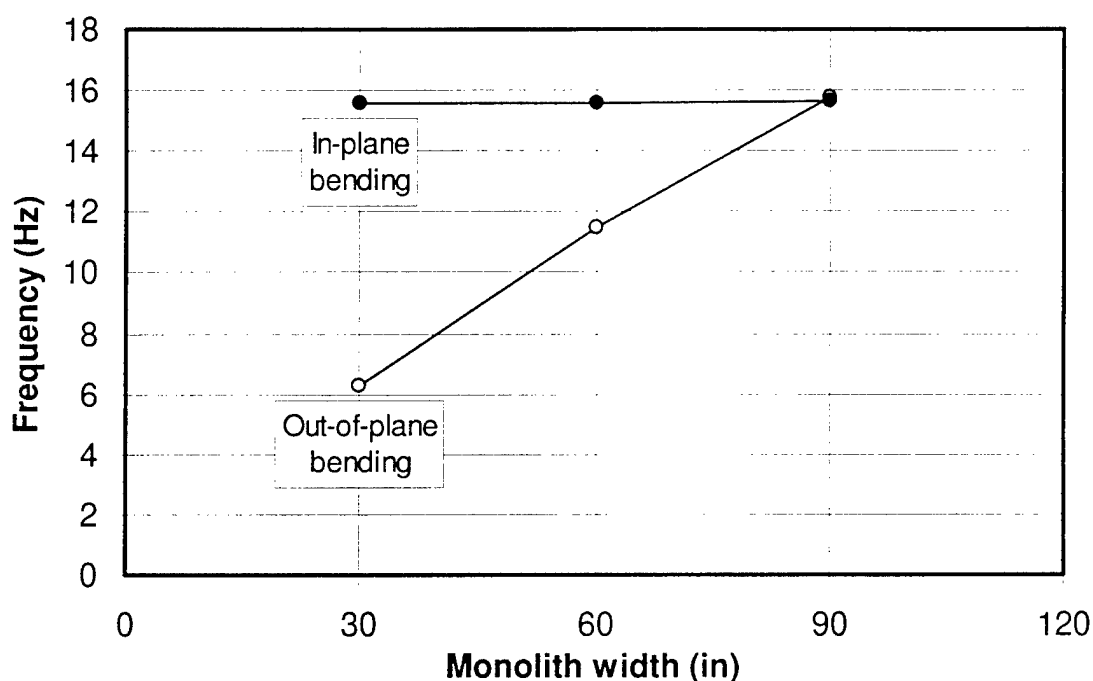
Figure 2. The frequency variation of the 1st out-of-plane and in-plane modes of vibration with respect to model width.

In terms of 30 in. (0.76 m) scaled monolith increments, the 60 in. (1.52 m) model width provides the best model width because unlike the 90 in. (2.29 m) model, it should not respond with unwanted out-of-plane motions when excited by in-plane support motions. Therefore, it was decided to use a 60 in. (1.52 m) model width for the Koyna dam failure tests (see Chapter 1, Figure 1). (Data reported in Chapter 4 demonstrate that, in fact, no significant out-of-plane motion did occur in the 60 in. model.

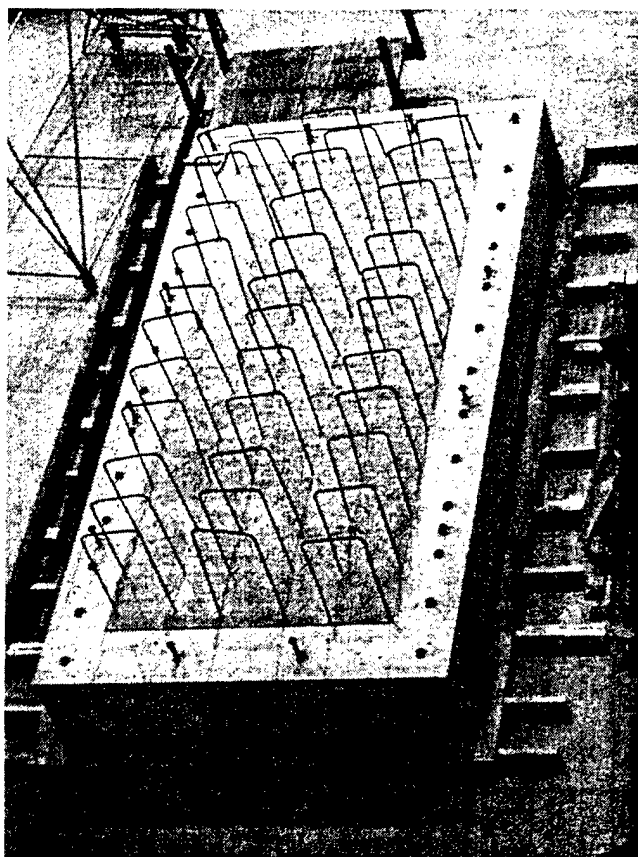
Figure 4. Base beam before attachment of longitudinal reinforcing steel and model formwork.

The dam model was anchored to the shake table by constructing a base beam that contained reinforcing steel which extended 24 in. (0.61 m) above the base beam and into the model. This reinforcing steel prevented any cracking or slip-

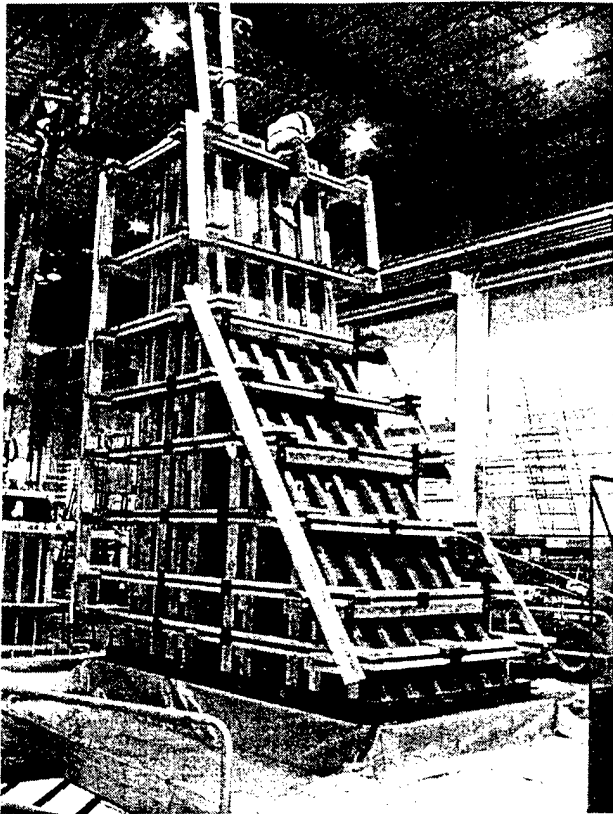
Figure 5. Downstream and front face of dam formwork.

The formwork was designed to resist the full hydrostatic pressure of the model material. The concrete used in the dam model was very fluid and was not expected to set-up until 24 hours after casting. Also, because of the fluid consistency of the concrete, the formwork needed to be almost watertight. Figure 5 shows the downstream and front face of the dam formwork soon after casting began. Note the pump line at the left side of the photograph. Figure 6 shows the back face of the dam formwork. The top of the formwork was 12 in. (0.305 m) above the top of the model so the material could be cast several inches above the desired elevation, allowing for the significant predicted settlement after casting. Specifically, a 2 percent reduction in concrete volume due to settlement was predicted, which meant the elevation at the top of the forms would drop almost 10 in. (0.25 m), leaving 10 in. (0.25 m) of water at the top. Appendix A provides more details on formwork design and detailing. The formwork was almost entirely wood, but incorporated steel angle irons to resist the uplift forces from the sloped downstream face. Vertical steel angles on the front and back faces transferred loads from the downstream walers to horizontal angles at the base of the model. Horizontal angles went around the perimeter of the formwork and anchored it to the base beam during casting.

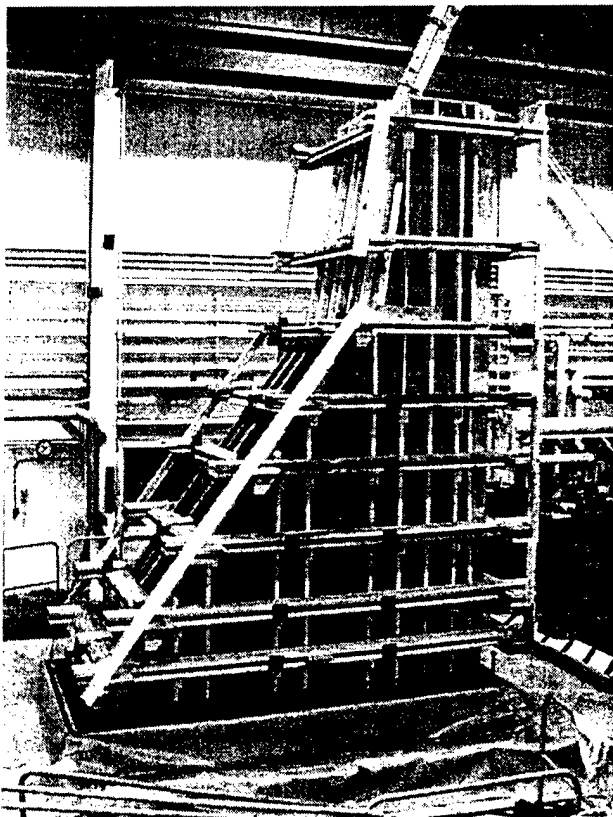
Figure 6. Back face of dam formwork.

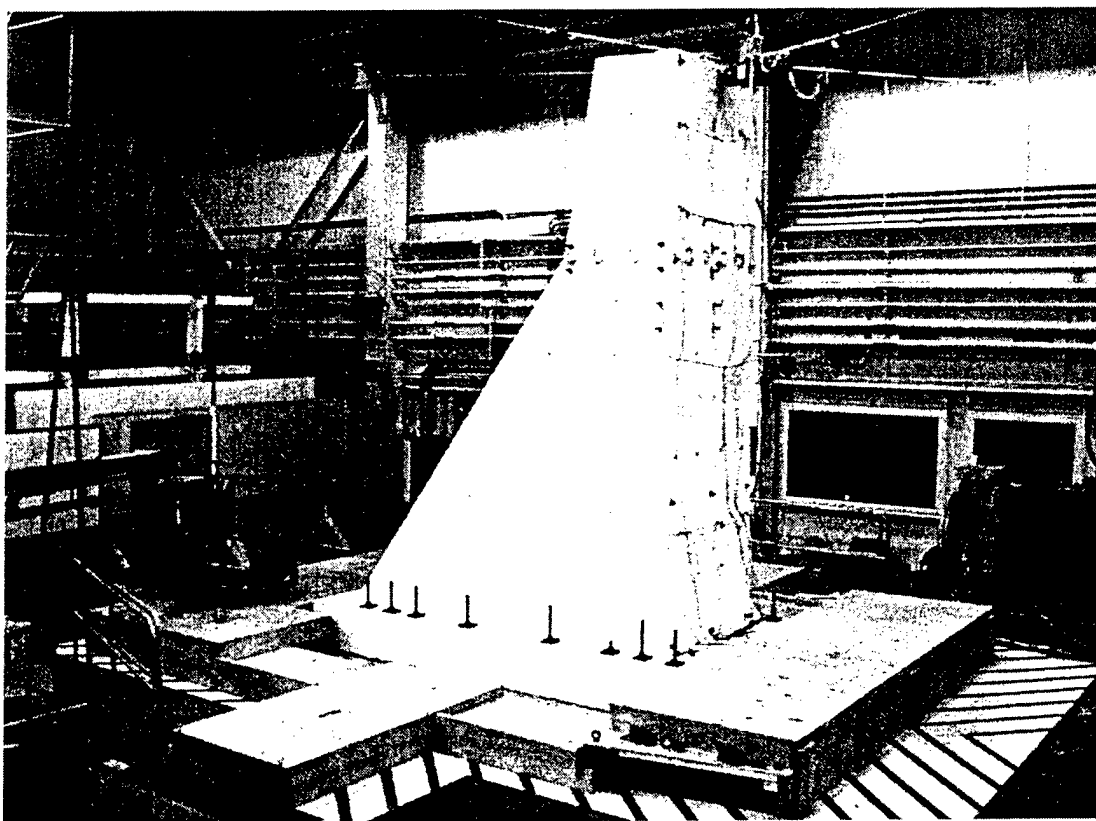
Figure 7. Koyna dam model during modal testing using a 50 lb (222 N) shaker at its top, showing the TESS protection frame around its base.

Before conducting any shake table tests, modal tests were conducted using a 50 lb (222 N) electrostatic shaker. (Figure 7 (Chapter 2) shows this shaker attached to the upstream face of the dam model.) The shaker stinger was attached to a force transducer that was in turn attached to the plate used for the A10x, A10y and A10z accelerometers at the location shown at the top center of Figure 8. The shaker was supported vertically by the overhead crane, and was restrained from

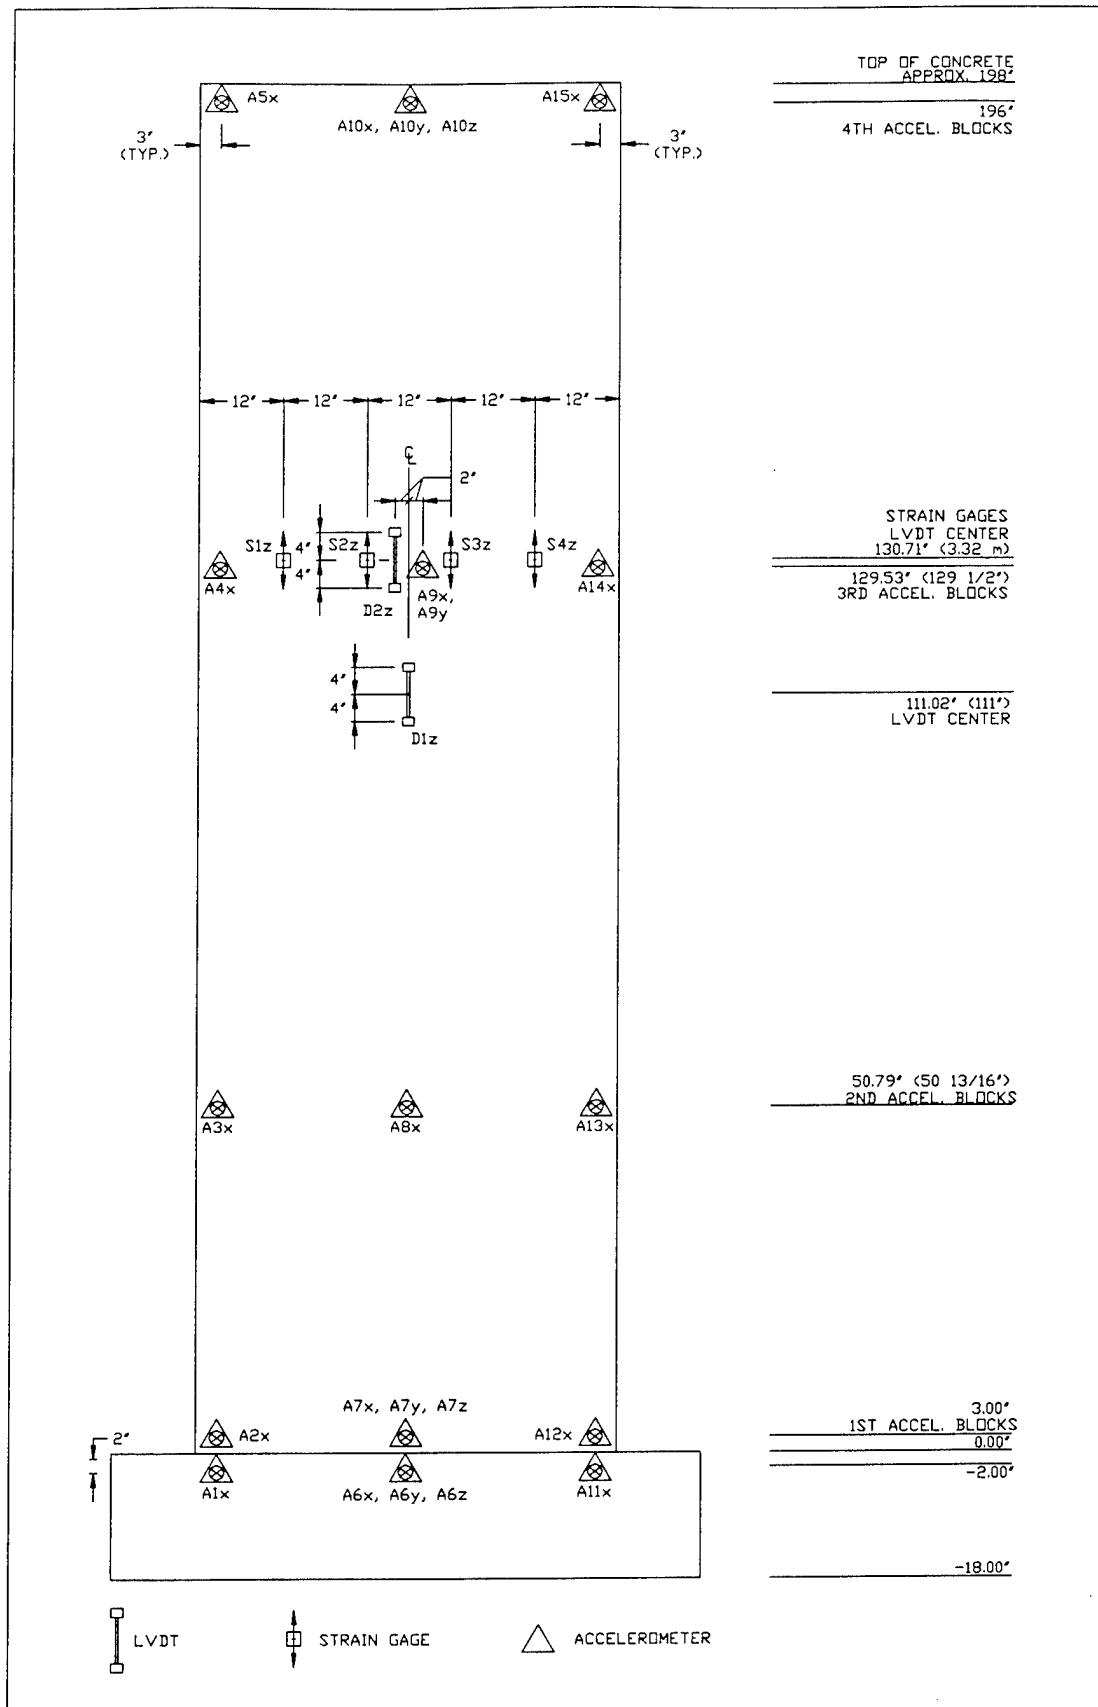
Figure 8. Location of accelerometers, strain gages, and LVDTs on upstream face of the model.

the formwork because of the significant leakage. (See Appendix B for a discussion of these casting issues). Figure 8 also shows the accelerometers mounted to the base beam (A1x, A6x, A6y, A6z, and A11x). All accelerometer sensor numbers begin with A (e.g., A1x), all strain gage sensor numbers begin with S (e.g., S1z), and all LVDT sensor numbers begin with D (e.g., D1z). All accelerometers with the same number (e.g., A6x, A6y and A6z) have the same location. The letter at the end of the sensor number (i.e., x, y or z) indicates the direction of measurement as shown in Tables 3, 4, and 5. Sensor number ATx provides the average acceleration in the x direction, as measured by sensors inside the TESS. The accelerometers attached to the base beam represent the input motions driving the model and these should be in agreement with the table motions (ATx). Figure 8 shows that three columns of accelerometers were installed on the upstream face to check for any undesired torsional response. For example, if A5x, A10x, and A15x measure essentially the same motion, there is not a torsional response. The accelerometers located just above the base beam (A2x, A7x, A7y, A7z, and A12x) were installed there to check for slippage of the model along the surface of the base beam. Each accelerometer was mounted to a block that was in turn screwed or adhered to the plates cast into model,<sup>6</sup> as indicated Figures A7, A8, and A9 (Appendix A). For each LVDT, two plates were cast into the model at the locations indicated in Figures A7, A8, and A9. One side of each LVDT was attached to the two LVDT plates. The centers of the plates were spaced 8 in. (203 mm) apart so the sensors would measure the relative displacement between the two locations, as shown in Figure 8.

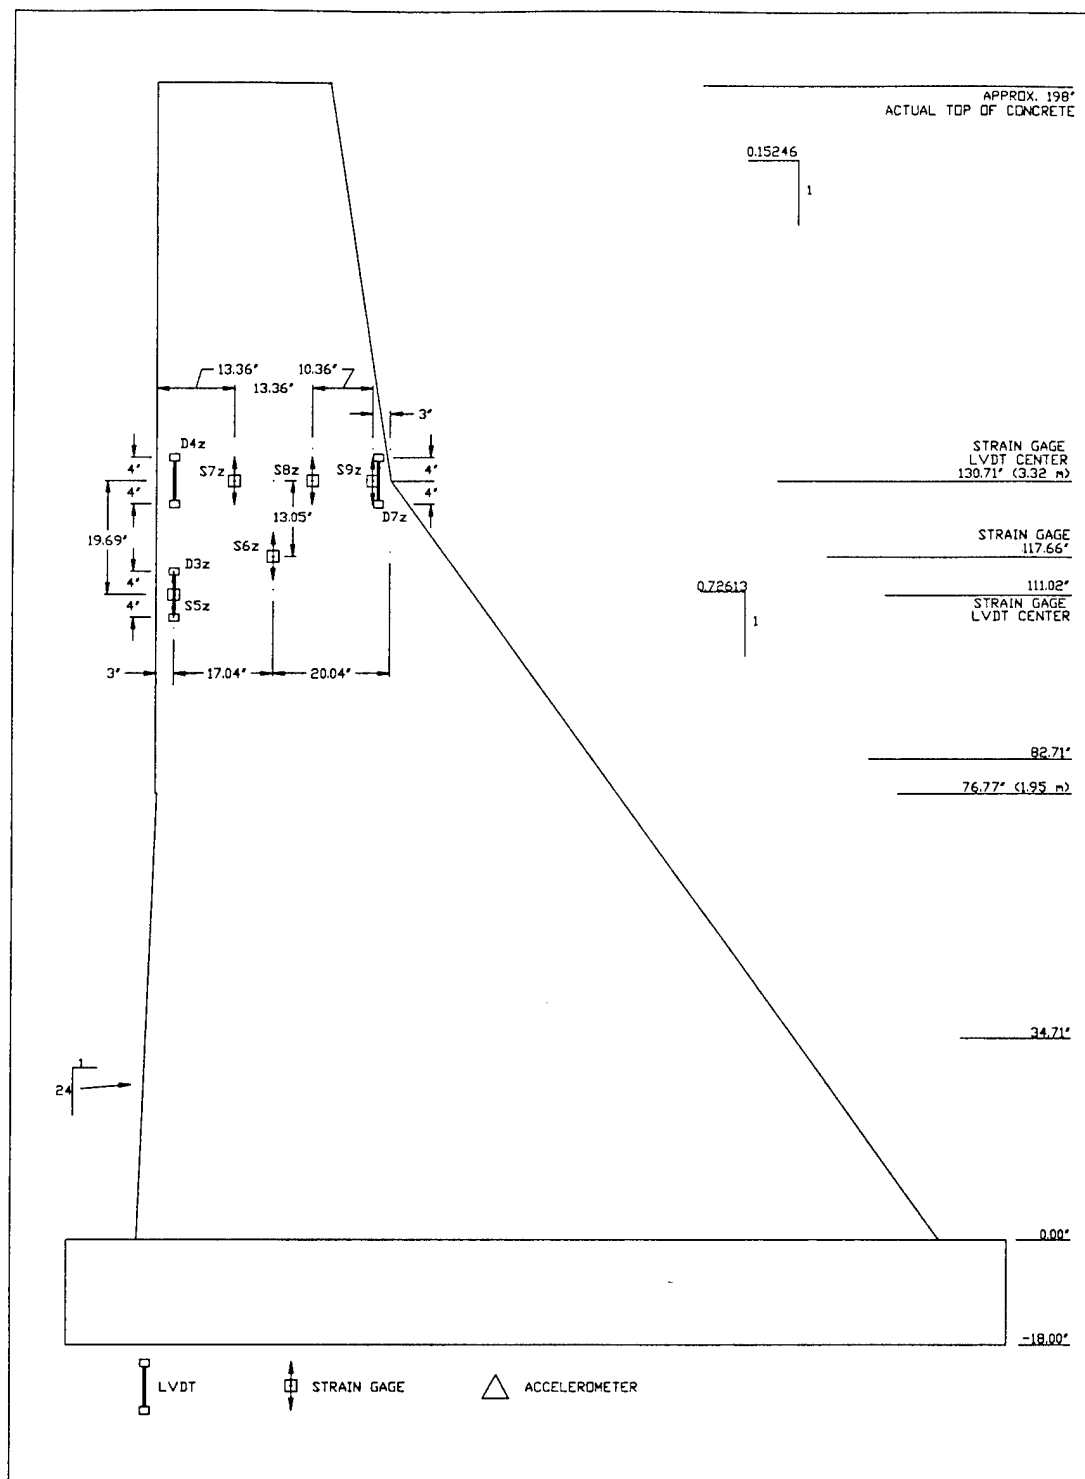
Figure 9. Location of each strain gage and LVDT mounted on the front face of the model.

Figure 9 shows the location of each strain gage and LVDT mounted on the front face of the model. The front and back faces did not have accelerometers. As with the upstream face, the strain gages and LVDTs were located near the expected failure surface, with the predicted crack either propagating diagonally down from the change in slope on the downstream face, or straight across from the change in slope.

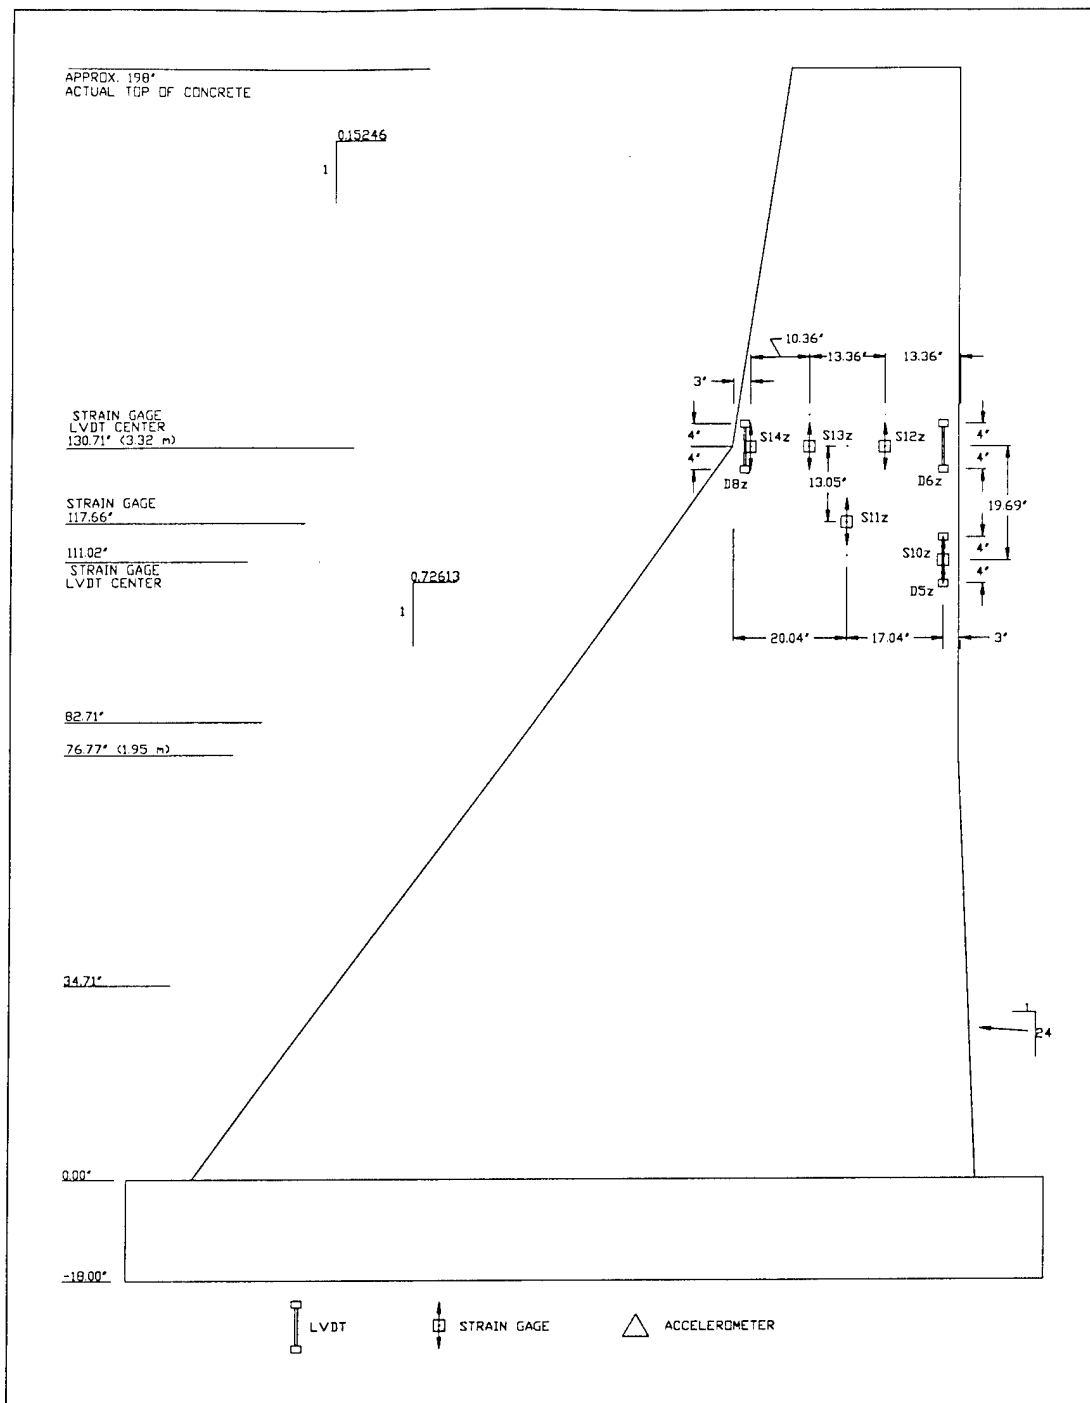
Figure 10. Strain gage and LVDT instrumentation on the back face of the model.

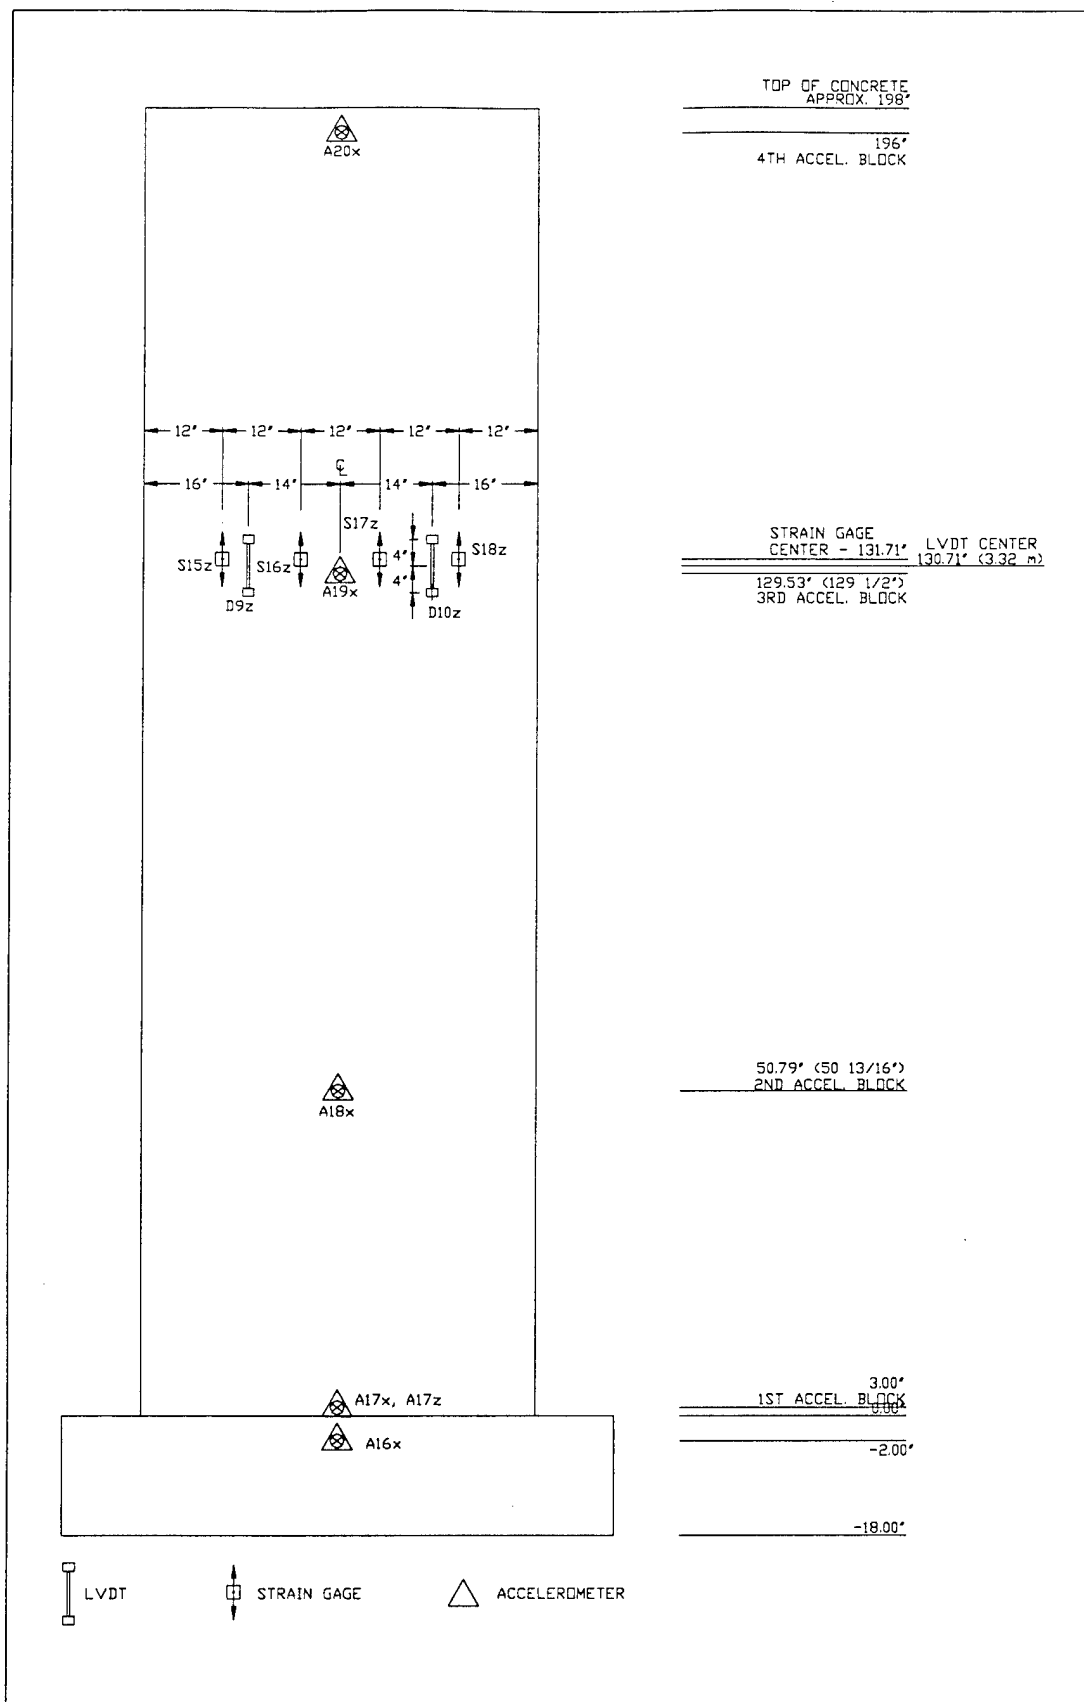
Figure 11. Locations of all sensors on the downstream face of the model.

Figure 11 shows the locations of all sensors on the downstream face. This face contains one column of five accelerometers. All the strain gages and LVDTs were located near the change in slope on this face, where the crack was expected to begin. Figure 11 shows that the A19x accelerometer block was centered 1.2 in. (30 mm) below the change in slope and the strain gages were centered 1 in. (25 mm) above the change in slope. The LVDTs were centered on the change in slope, spanning across this location and oriented as shown in Figure A15 (Appendix A).

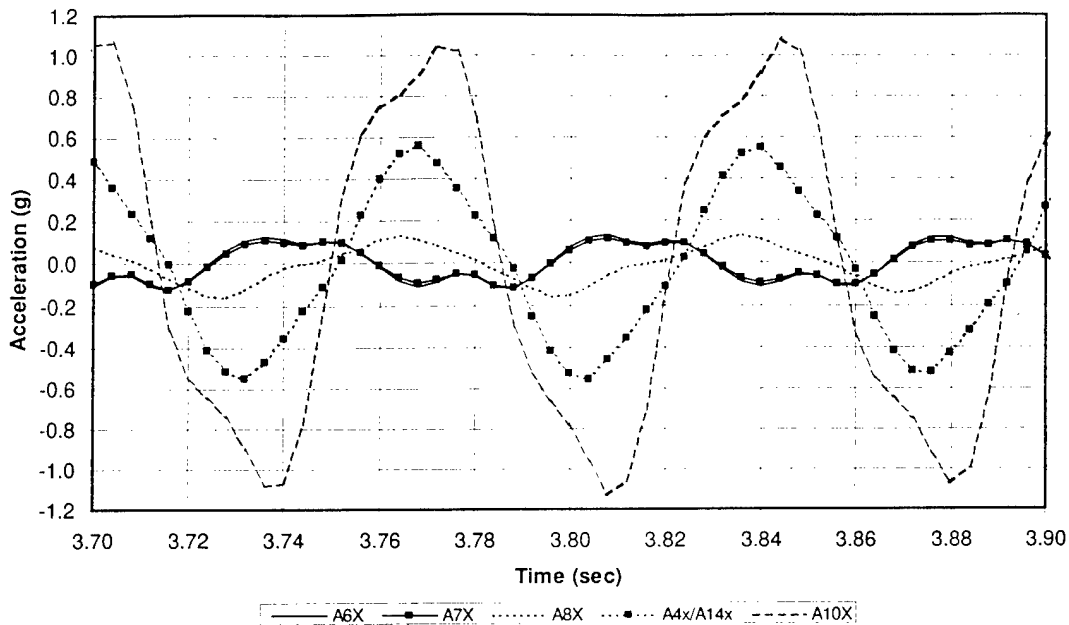
Figure 18. Measured acceleration at the base beam, model base, and elevations of 50.8 in., 129.5 in., and 195 in. between 3.7 and 3.9 sec.

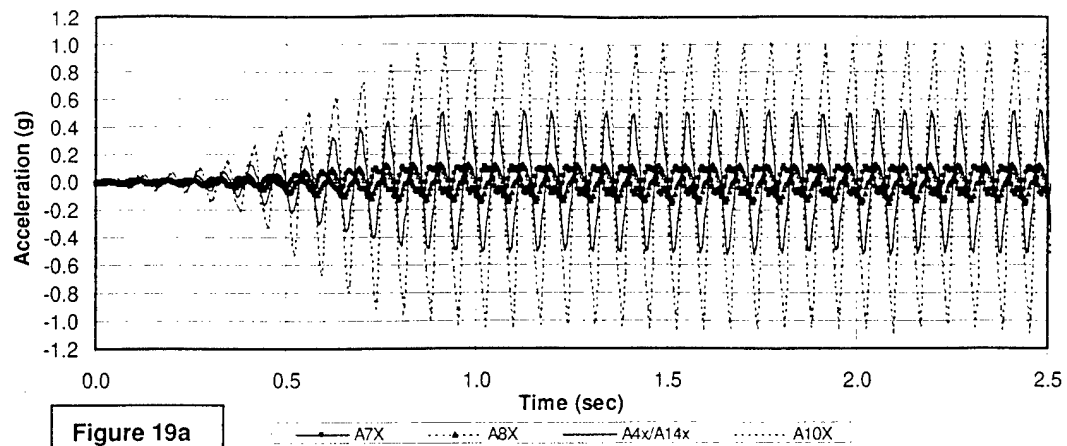
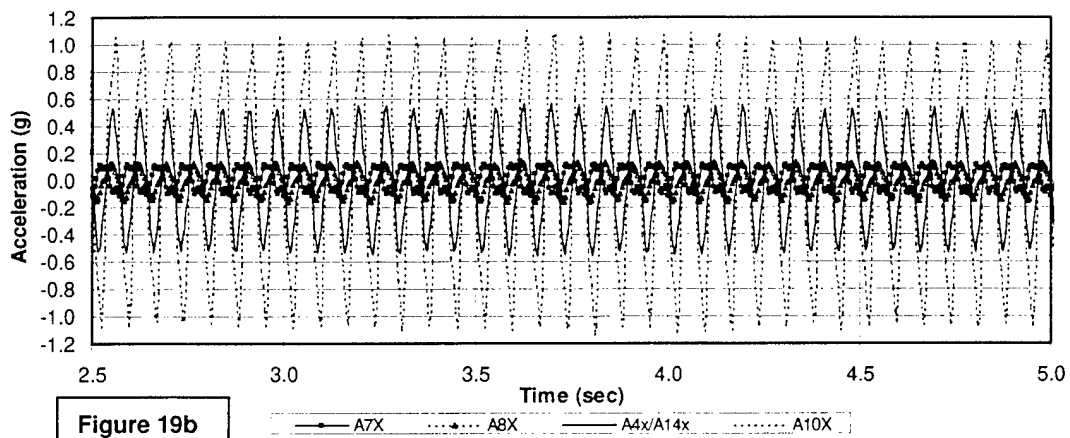
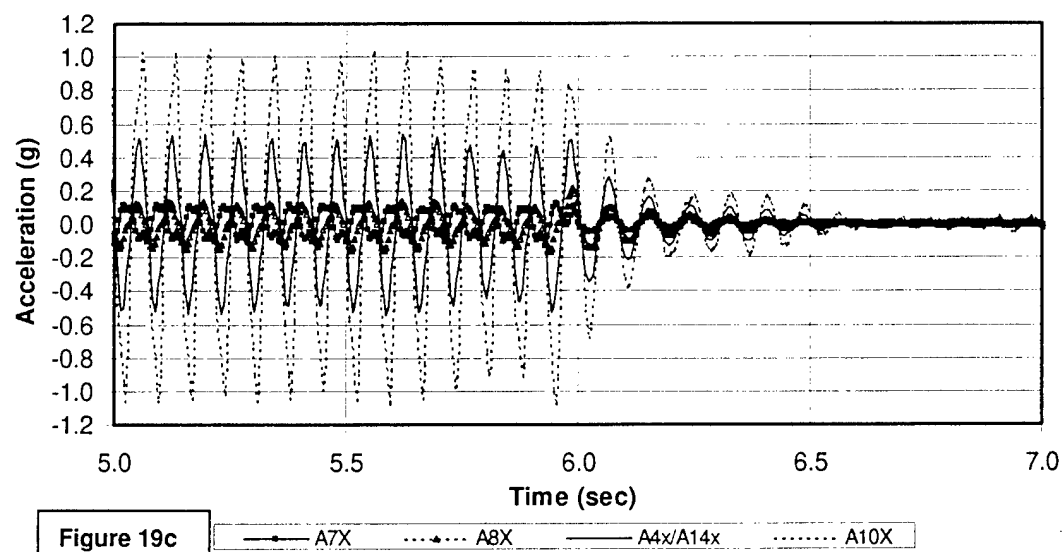
Figure 19. Measured (absolute) accelerations along the upstream face over entire test duration.

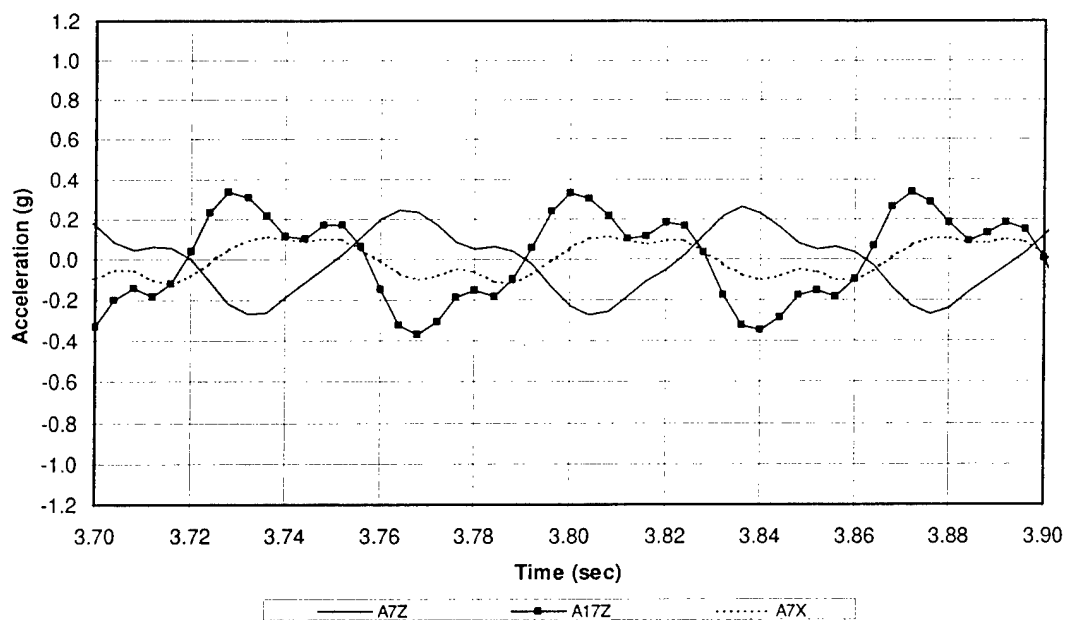
Figure 20. Overturning accelerations relative to in-plane horizontal accelerations.

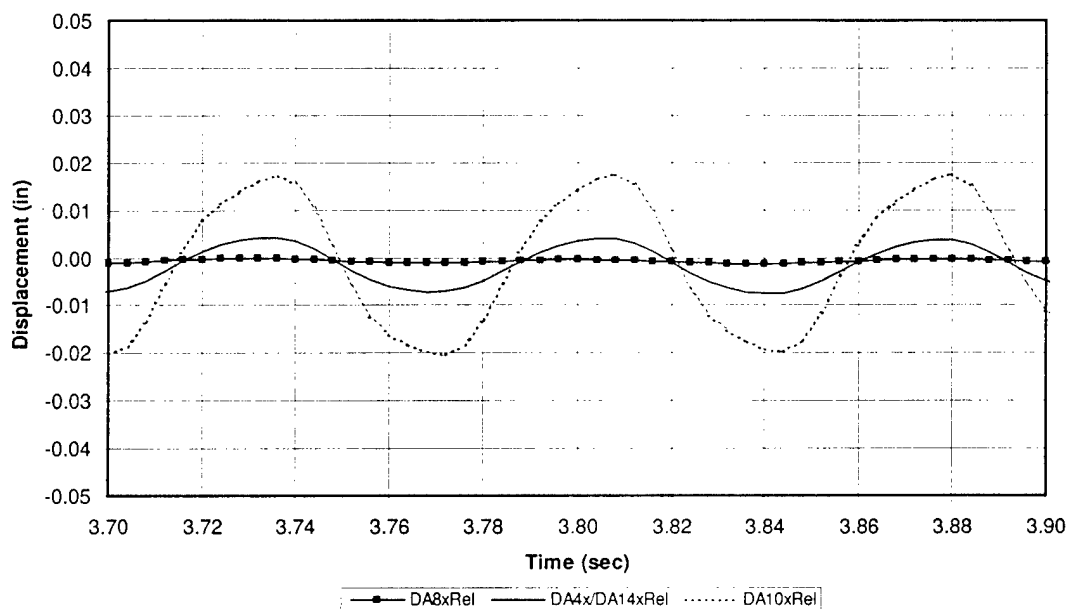
Figure 22. Relative displacements along the model upstream face showing the model deformation for the Sine5 test.

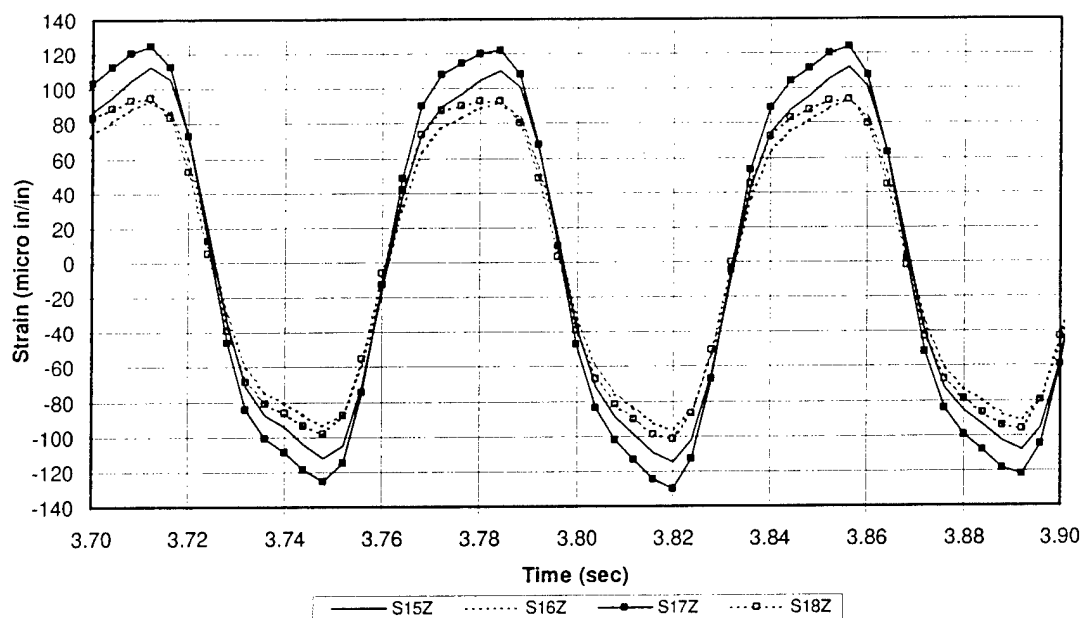
Figure 25. Strain measurements along the downstream face.

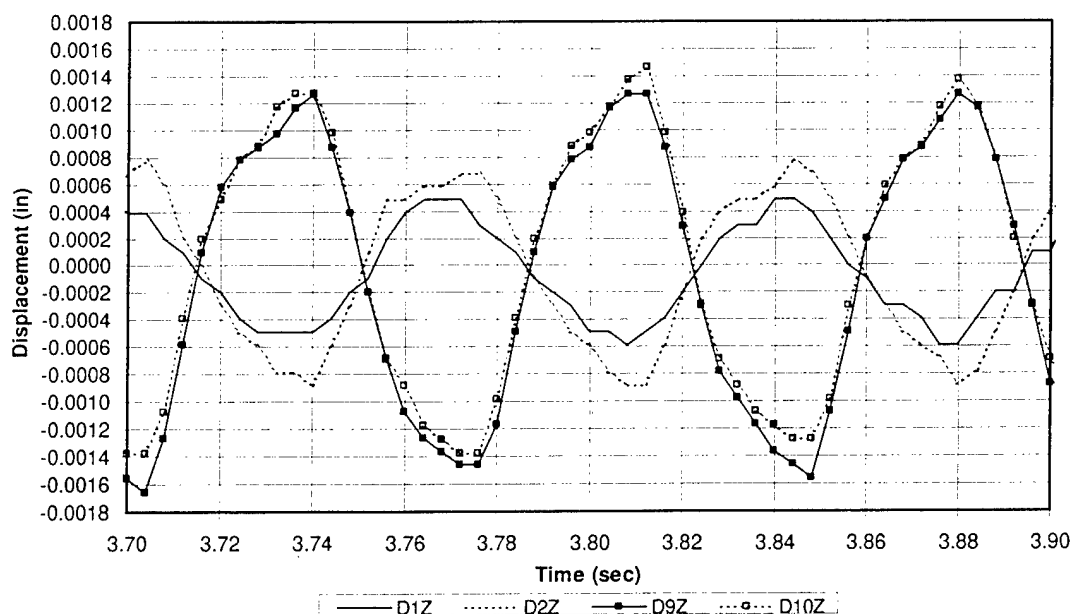
Figure 31. LVDT measurements at the upstream and downstream faces of the Sine5 test.

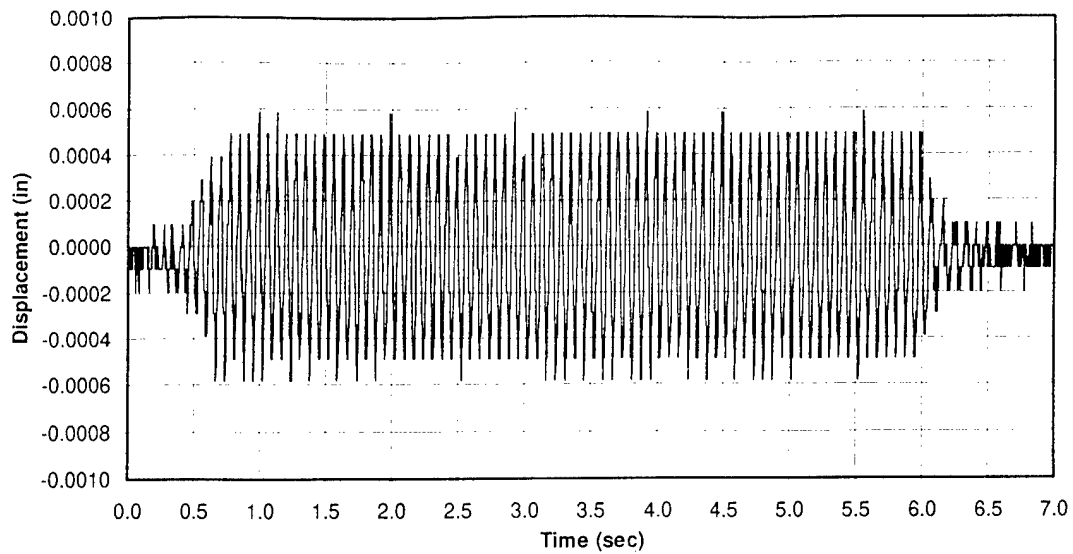
Figure 33. D1z LVDT deformation on the downstream face for the entire Sine5 test.

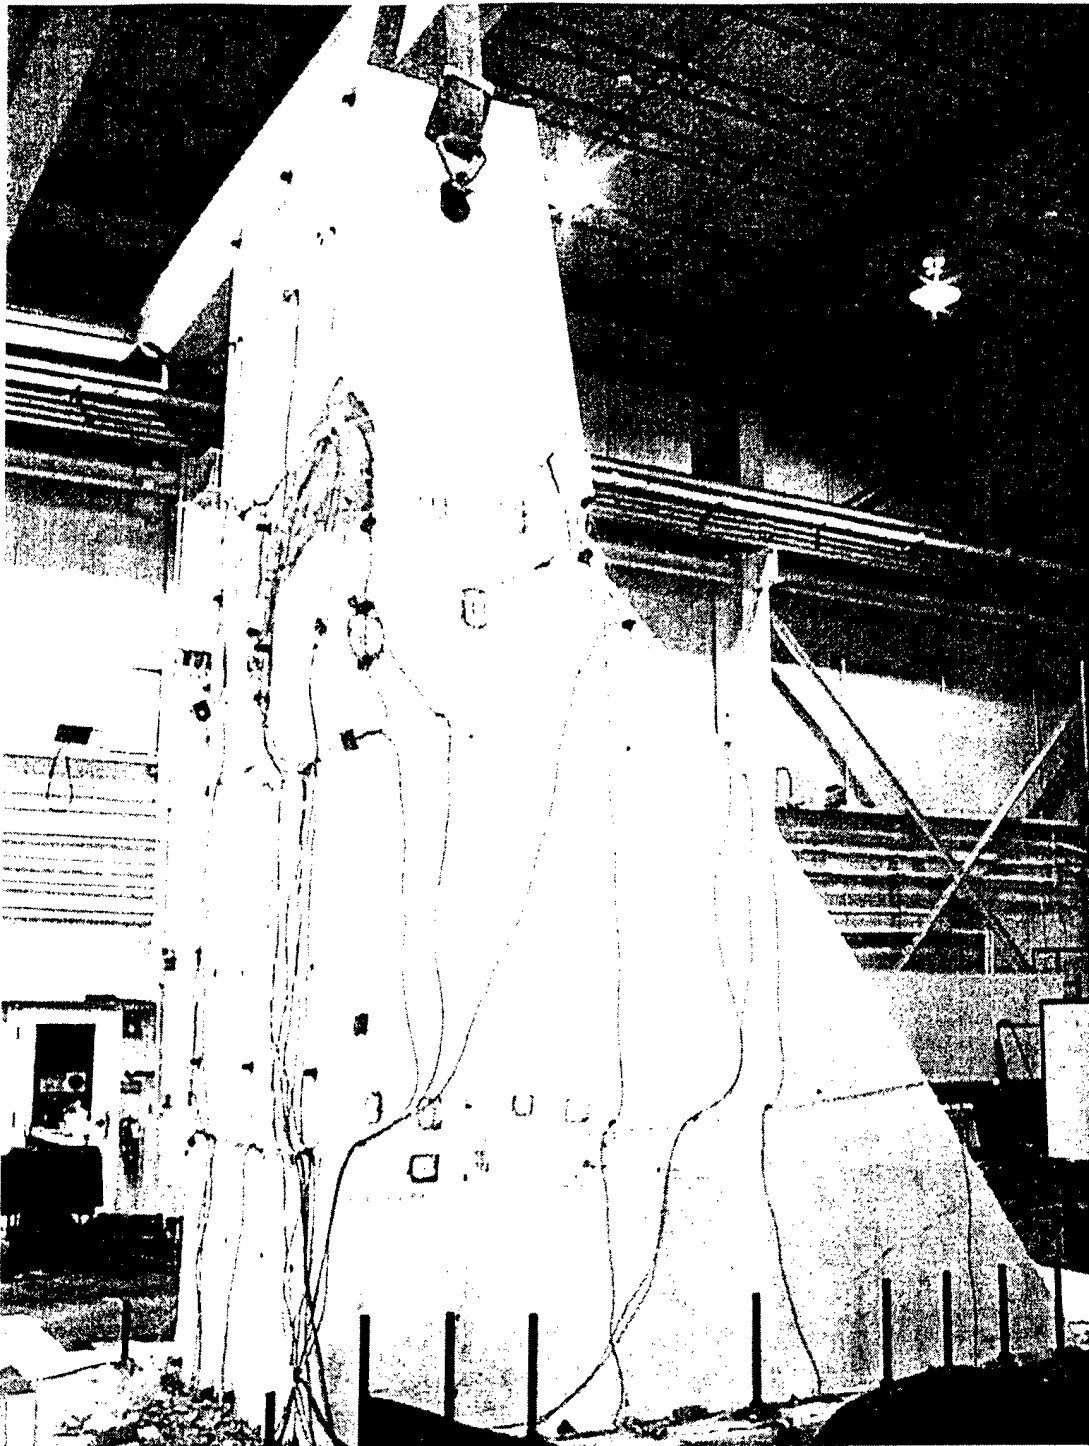
Figure 35. Overall front face view of the dam model after failure in the Sine6 test.

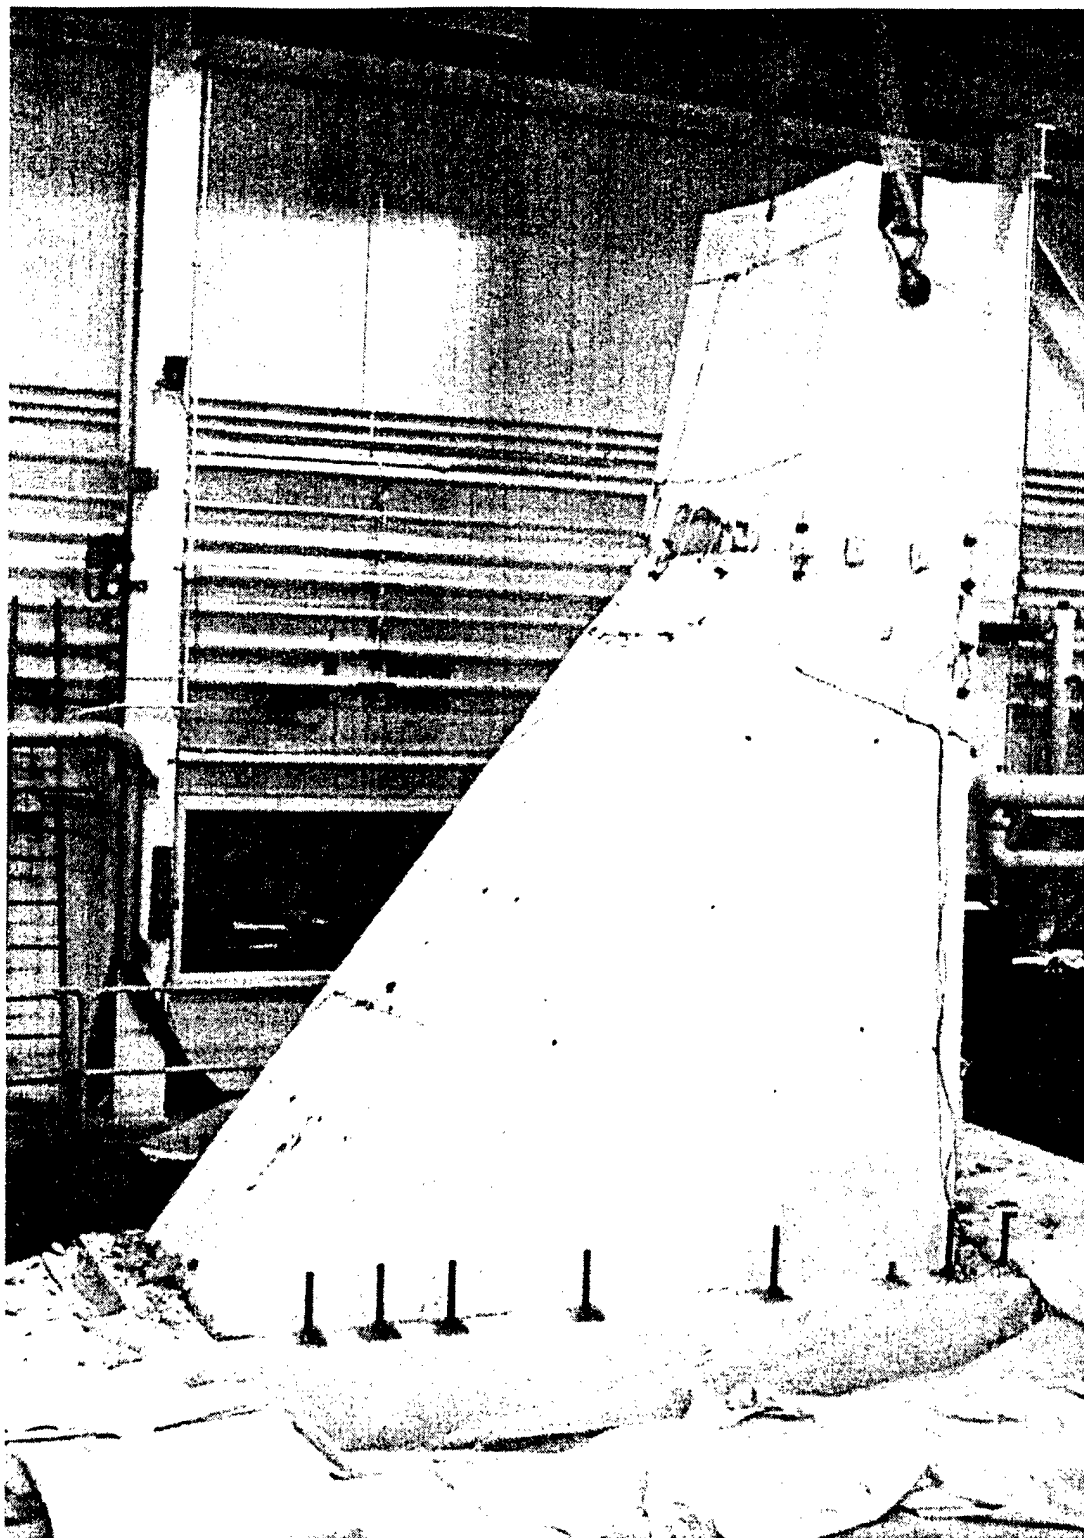
Figure 36. Overall view of the back face of the dam model.

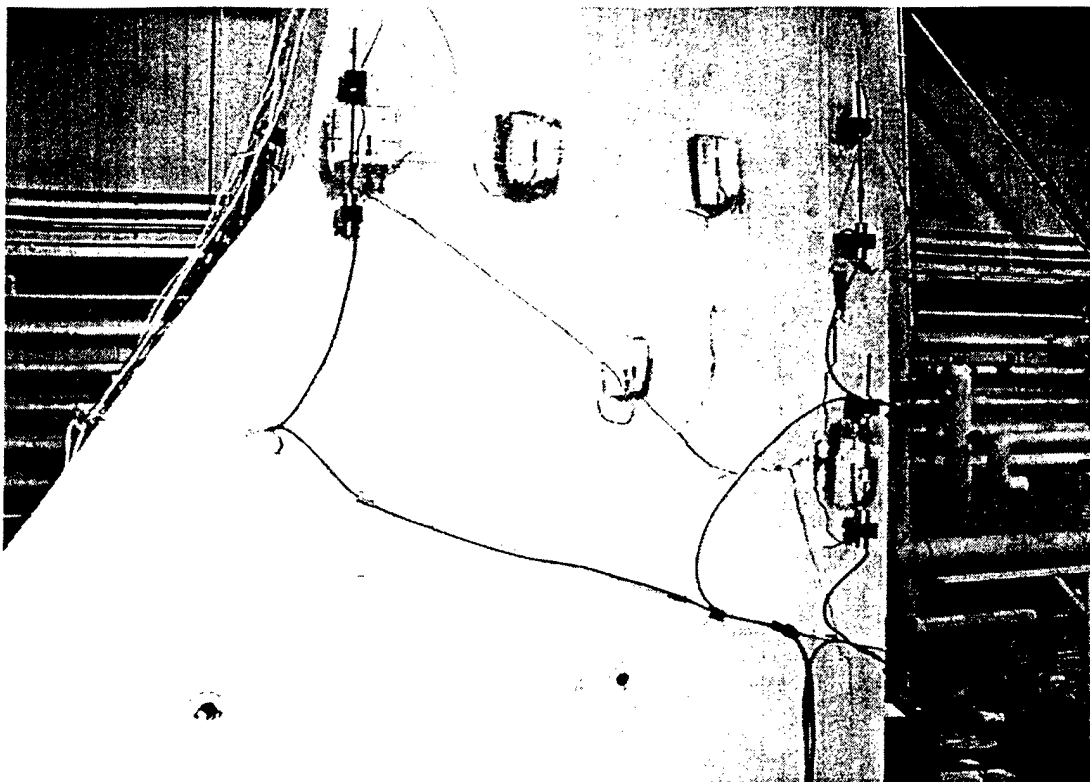
Figure 37. A close-up of the crack on the back face of the dam model.
